Manhole Inspection Summary

Manhole # S39EE_039MH

Location Address: **1202 TURPIN LN**

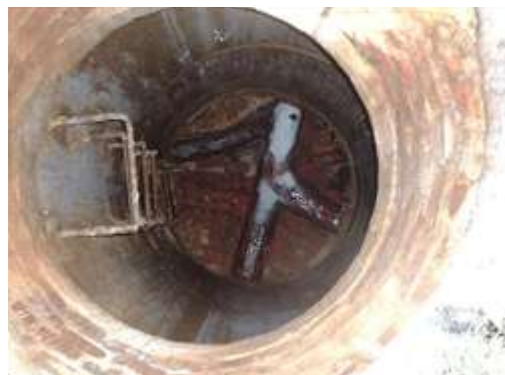
Top View

Adjustment deterioration and infiltration.
Corbel and Barrel infiltration. Bench
debris.

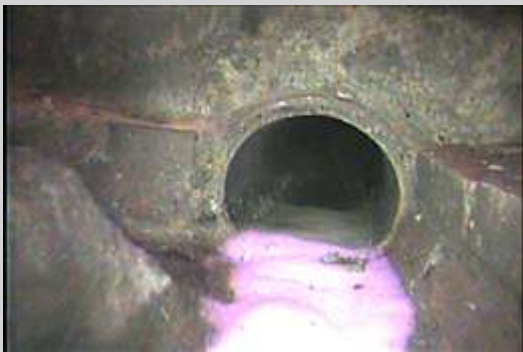
8 in. Circular Gravity Sewer Pipe Out @ 12 O'Clock

Pipe Material: **Clay** ☐ Pipe Lined

Invert Depth: **12.12** (ft.) Flow Characteristics: **Slow**

Infiltration: **None** Pipe Seal Cond: **Unknown**

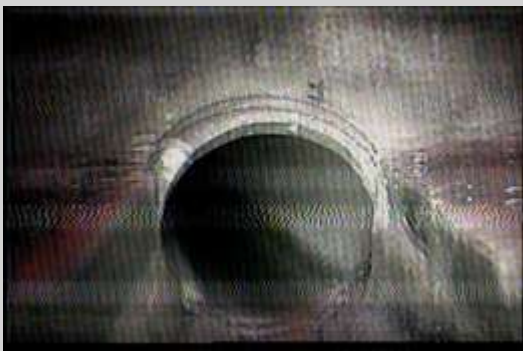
8 in. Circular Gravity Sewer Pipe In @ 3 O'Clock

Pipe Material: **Clay** ☐ Pipe Lined

Invert Depth: **12.06** (ft.) Flow Characteristics: **Slow**

Infiltration: **None** Pipe Seal Cond: **Unknown**

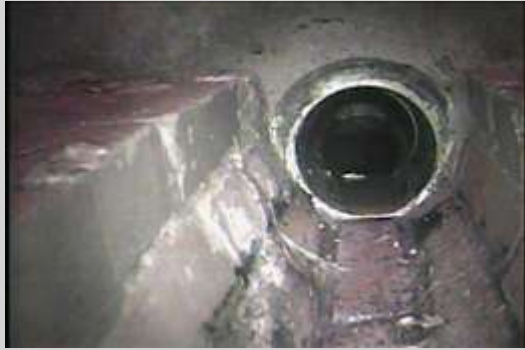
6 in. Circular Gravity Sewer

Pipe Material: **Clay** ☐ Pipe Lined

Invert Depth: **11.87** (ft.) Flow Characteristics: **None**

Infiltration: **Evidence** Pipe Seal Cond: **Unknown**

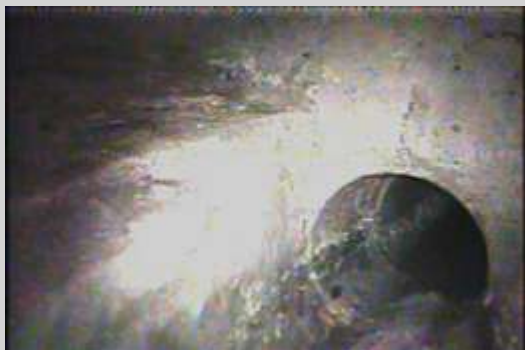
6 in. Circular Gravity Sewer

Pipe Material: **Clay** ☐ Pipe Lined

Deposits: ☐ None ☐ Mud ☐ Sludge ☐ Debris ☒ Grease

Silt Depth: **0** (in.) Deposits Extent: **Light**
